**POTENTIALLY RESPONSIBLE PARTIES (PRP) OVERSIGHT REPORT
FOR
SAN JACINTO RIVER WASTE PITS SITE
HOUSTON, HARRIS COUNTY, TEXAS**

U.S. Environmental Protection Agency Region 6
1445 Ross Avenue
Dallas, Texas 75202

June 7, 2010

Dynamac Corporation
1202 Executive West
Richardson, Texas 75081
(214) 575-3344

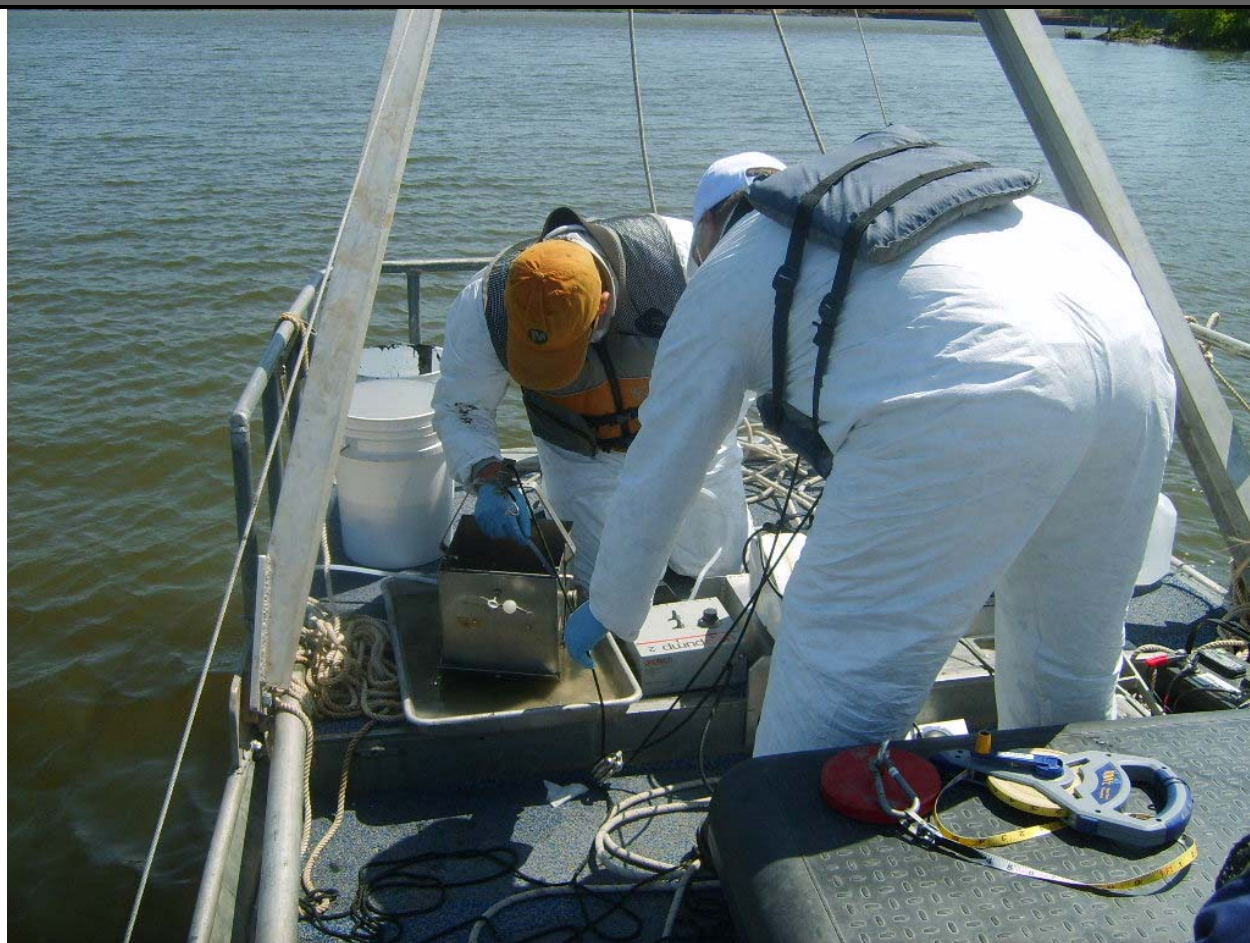
Logbook Photo #	102-0723
US EPA ID / Task Order Number	TXN000606611 / TO-0002-10-03-02
Site	San Jacinto River Waste Pits
Location Address	29.7944 N, 95.0625 W
City, State, ZIP code	Baytown, Texas
County	Harris
Direction/Orientation	East
Date	April 13, 2010
Time	1139 hrs
Photographer	Karen Berecz (START)
Witness	Jason Kase (PRP Contractor – Anchor QEA)
Description:	
Sample location SJA4

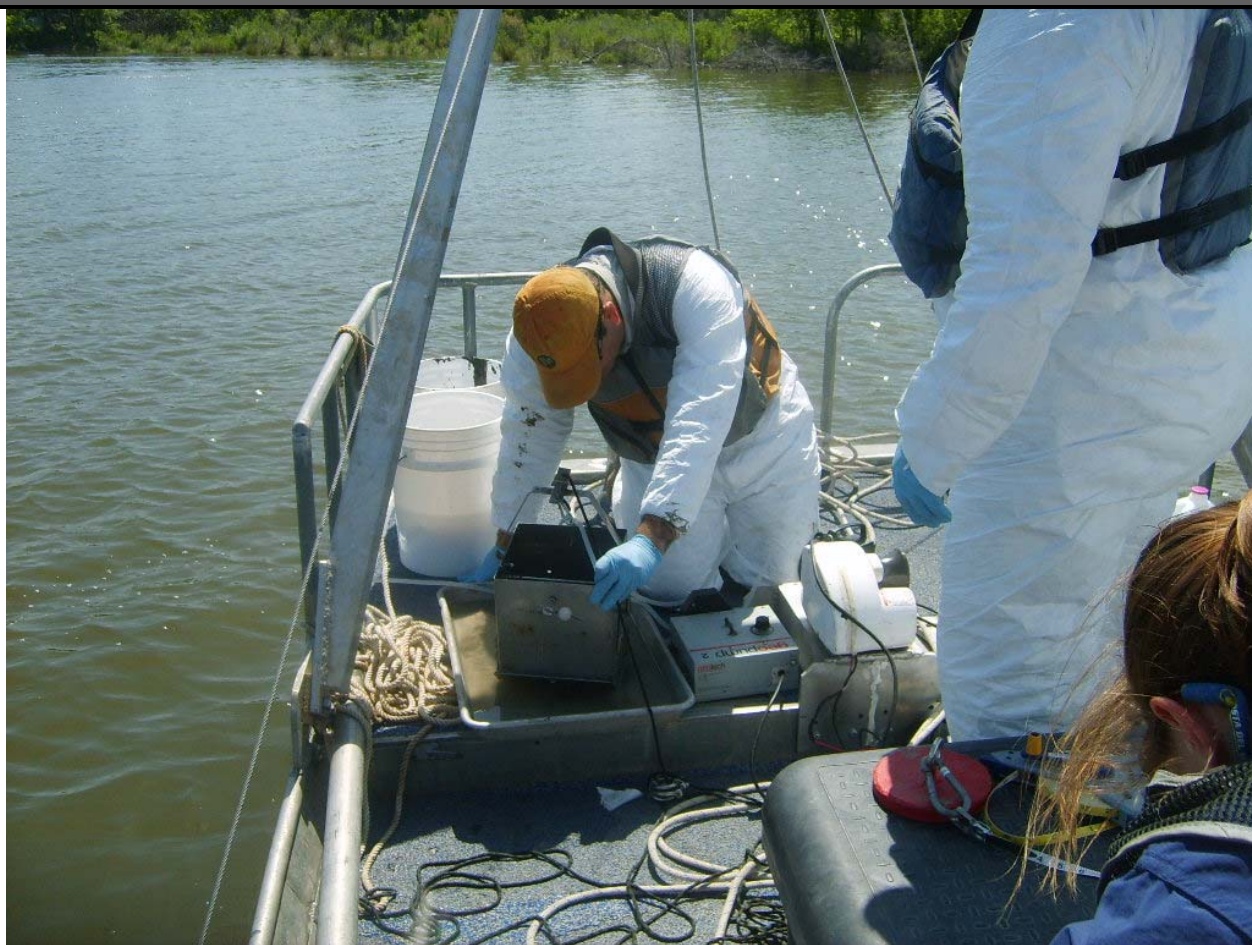
Logbook Photo #	102-0724
US EPA ID / Task Order Number	TXN000606611 / TO-0002-10-03-02
Site	San Jacinto River Waste Pits
Location Address	29.7944 N, 95.0625 W
City, State, ZIP code	Baytown, Texas
County	Harris
Direction/Orientation	East
Date	April 13, 2010
Time	1139 hrs
Photographer	Karen Berecz (START)
Witness	Jason Kase (PRP Contractor – Anchor QEA)
Description:	
Sample location SJA4.

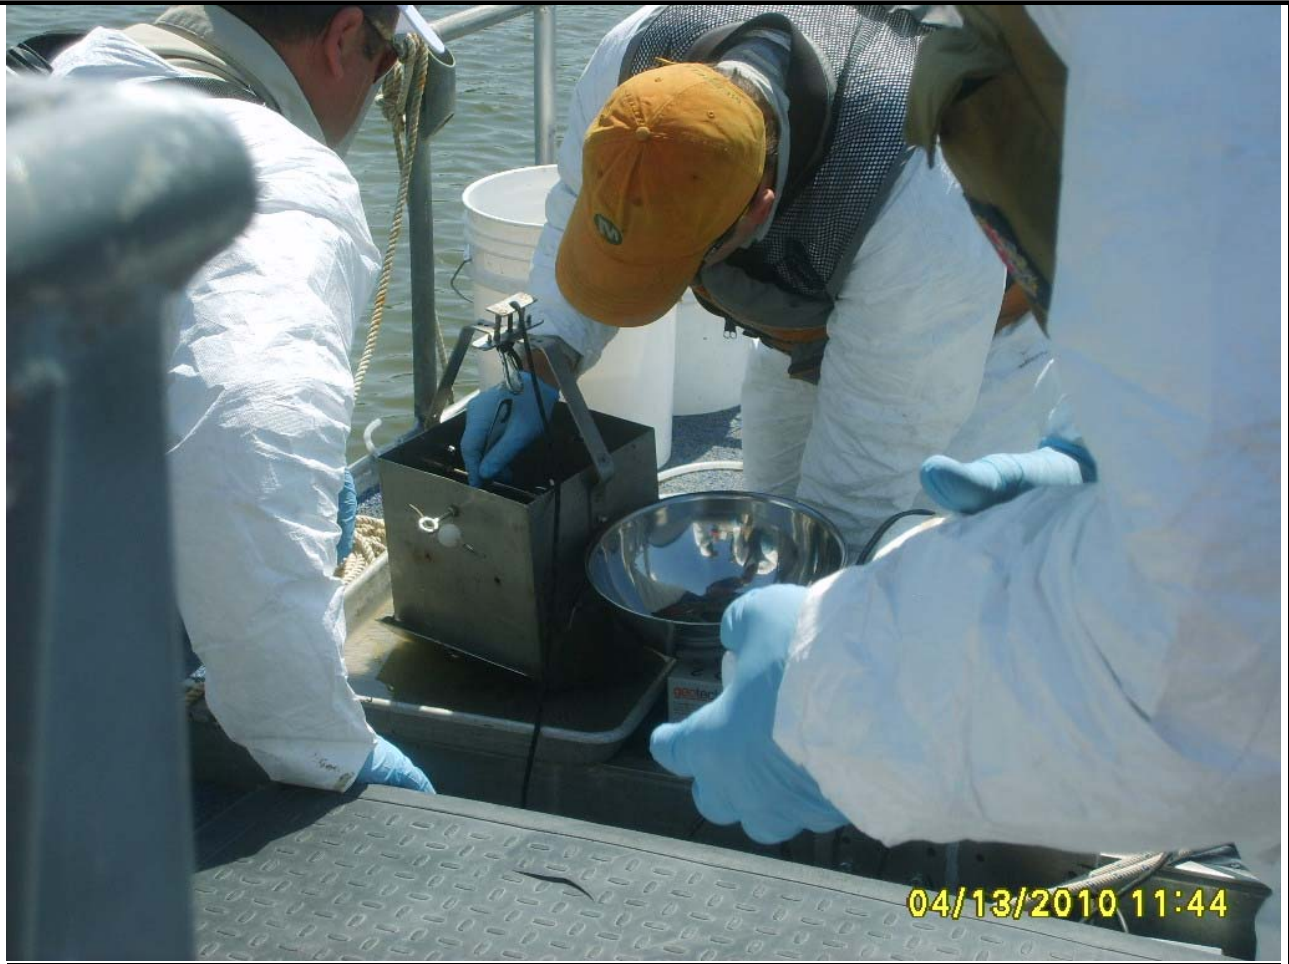
Logbook Photo #	102-0726
US EPA ID / Task Order Number	TXN000606611 / TO-0002-10-03-02
Site	San Jacinto River Waste Pits
Location Address	29.7944 N, 95.0625 W
City, State, ZIP code	Baytown, Texas
County	Harris
Direction/Orientation	East
Date	April 13, 2010
Time	1144 hrs
Photographer	Karen Berecz (START)
Witness	Jason Kase (PRP Contractor – Anchor QEA)
Description:	
Spoonng sediment from sampling unit to bowl. Site SJA4.

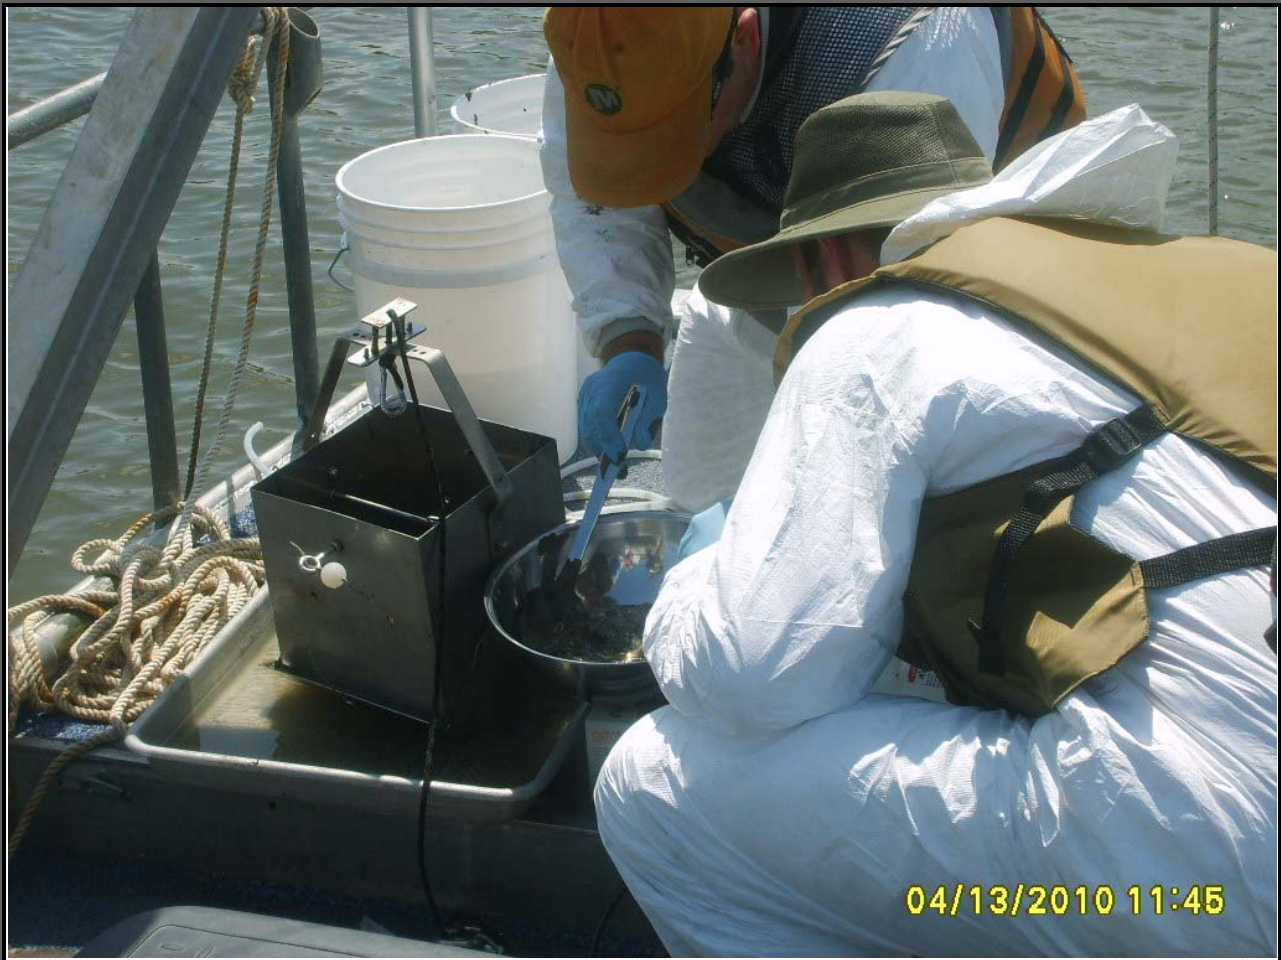
Logbook Photo #	102-0727
US EPA ID / Task Order Number	TXN000606611 / TO-0002-10-03-02
Site	San Jacinto River Waste Pits
Location Address	29.7944 N, 95.0625 W
City, State, ZIP code	Baytown, Texas
County	Harris
Direction/Orientation	East
Date	April 13, 2010
Time	1145 hrs
Photographer	Karen Berecz (START)
Witness	Jason Kase (PRP Contractor – Anchor QEA)
Description:	
Mixing sediment sample for site SJA4.

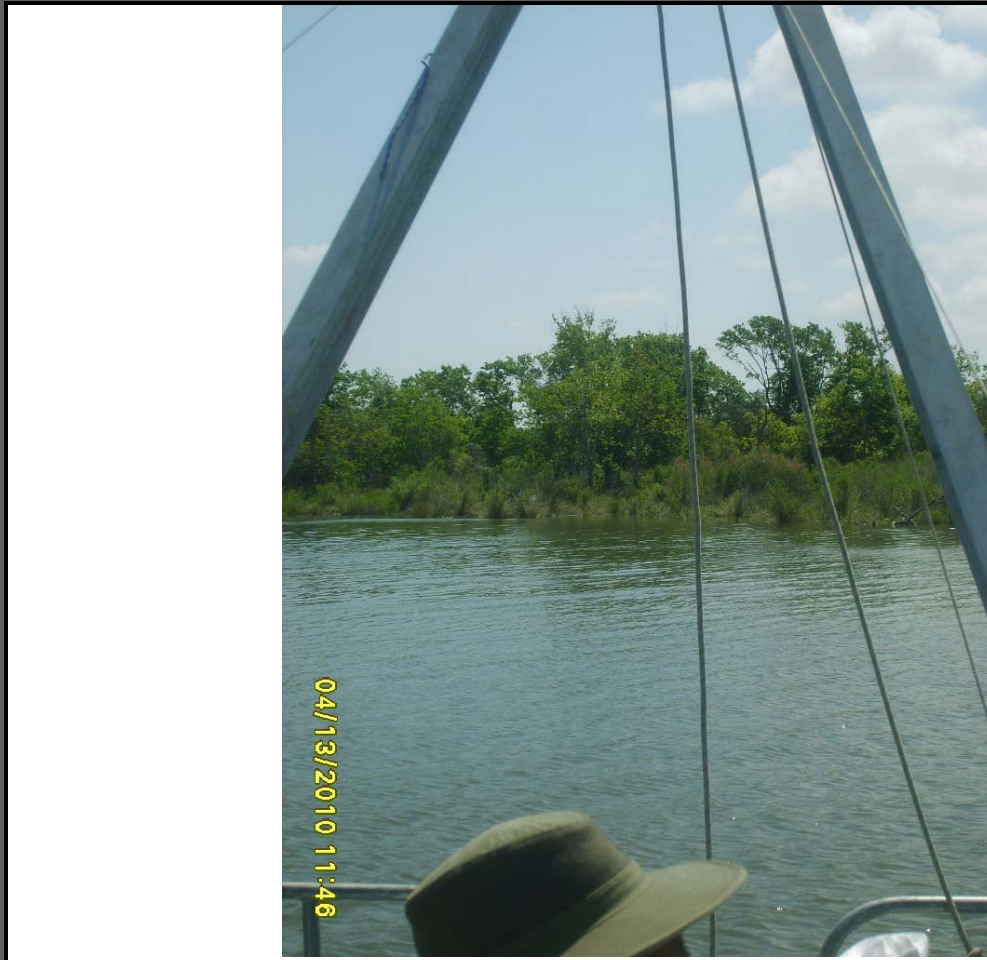
Logbook Photo #	102-0728
US EPA ID / Task Order Number	TXN000606611 / TO-0002-10-03-02
Site	San Jacinto River Waste Pits
Location Address	29.7944 N, 95.0625 W
City, State, ZIP code	Baytown, Texas
County	Harris
Direction/Orientation	Southeast
Date	April 13, 2010
Time	1146 hrs
Photographer	Karen Berecz (START)
Witness	Jason Kase (PRP Contractor – Anchor QEA)
Description:	
At transect A toward waste pits from SJA4.

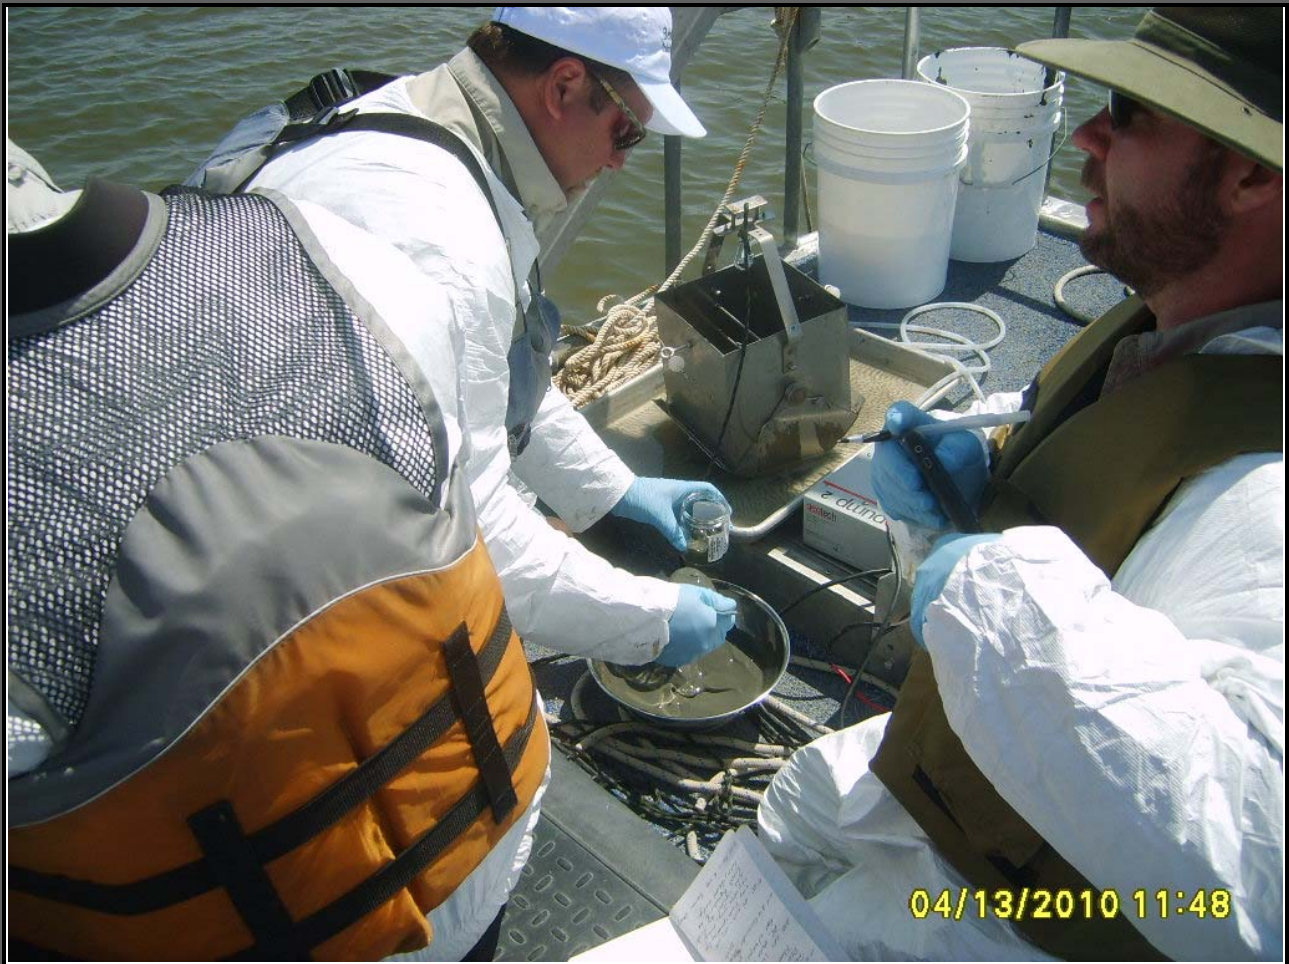
Logbook Photo #	102-0729
US EPA ID / Task Order Number	TXN000606611 / TO-0002-10-03-02
Site	San Jacinto River Waste Pits
Location Address	29.7944 N, 95.0625 W
City, State, ZIP code	Baytown, Texas
County	Harris
Direction/Orientation	East
Date	April 13, 2010
Time	1148 hrs
Photographer	Karen Berecz (START)
Witness	Jason Kase (PRP Contractor – Anchor QEA)
Description:	
Collecting SJA4 sediment sample.

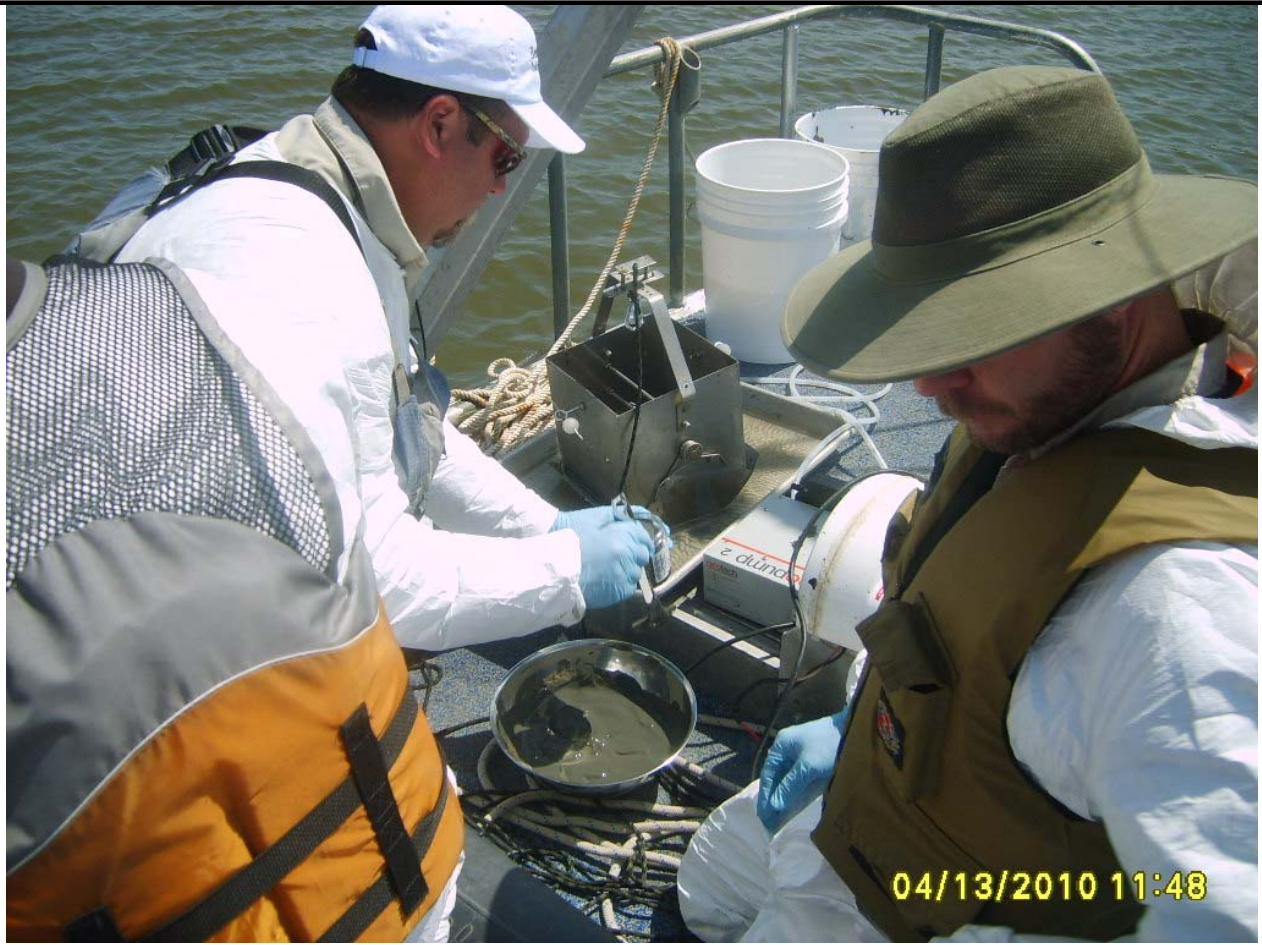
Logbook Photo #	102-0730
US EPA ID / Task Order Number	TXN000606611 / TO-0002-10-03-02
Site	San Jacinto River Waste Pits
Location Address	29.7944 N, 95.0625 W
City, State, ZIP code	Baytown, Texas
County	Harris
Direction/Orientation	East
Date	April 13, 2010
Time	1148 hrs
Photographer	Karen Berecz (START)
Witness	Jason Kase (PRP Contractor – Anchor QEA)
Description:	
Collecting SJA4 sediment sample.

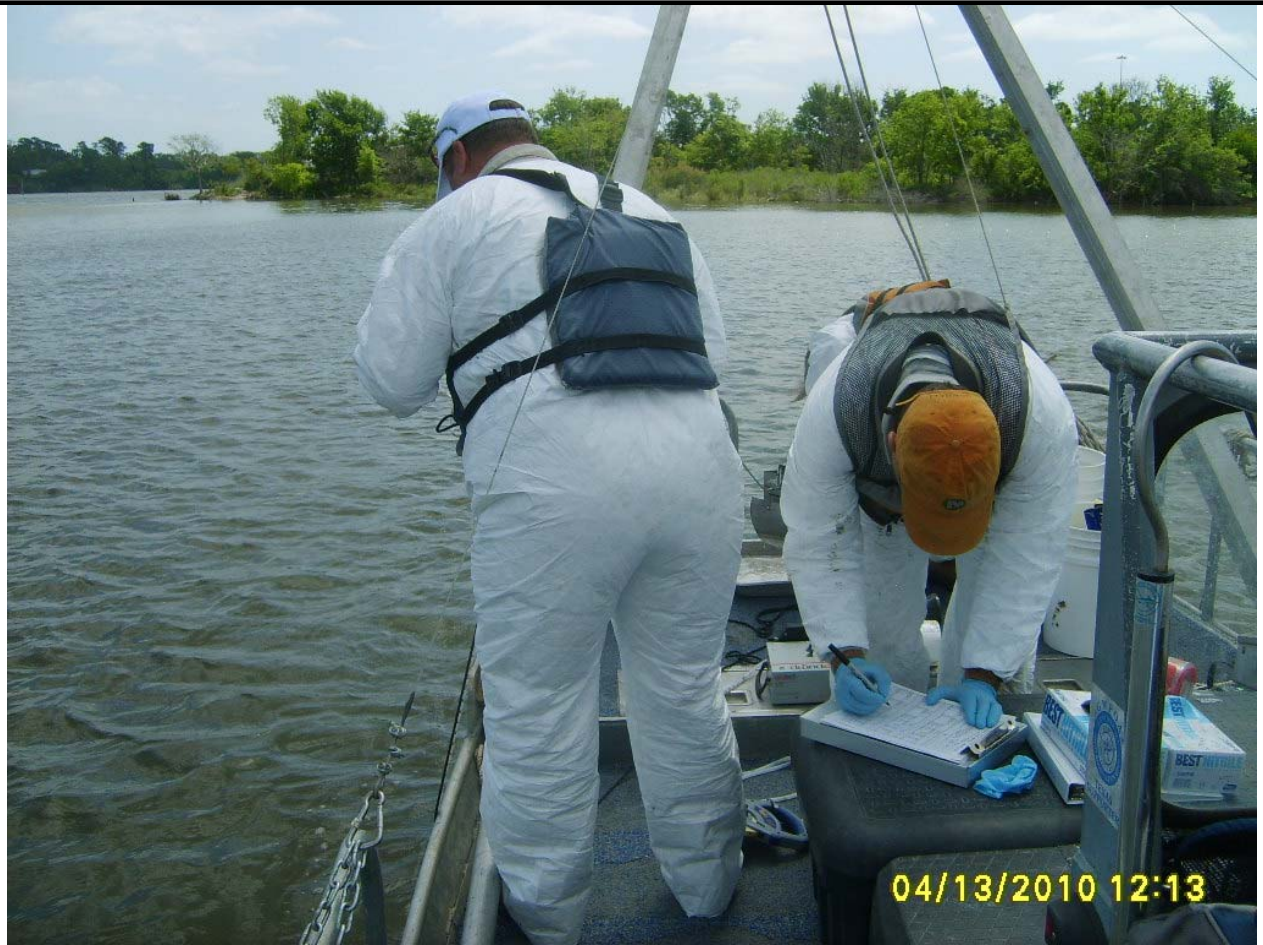
Logbook Photo #	102-0731
US EPA ID / Task Order Number	TXN000606611 / TO-0002-10-03-02
Site	San Jacinto River Waste Pits
Location Address	29.7944 N, 95.0625 W
City, State, ZIP code	Baytown, Texas
County	Harris
Direction/Orientation	North
Date	April 13, 2010
Time	1213 hrs
Photographer	Karen Berecz (START)
Witness	Jason Kase (PRP Contractor – Anchor QEA)
Description:	
Recording location and depth at station SJA5.

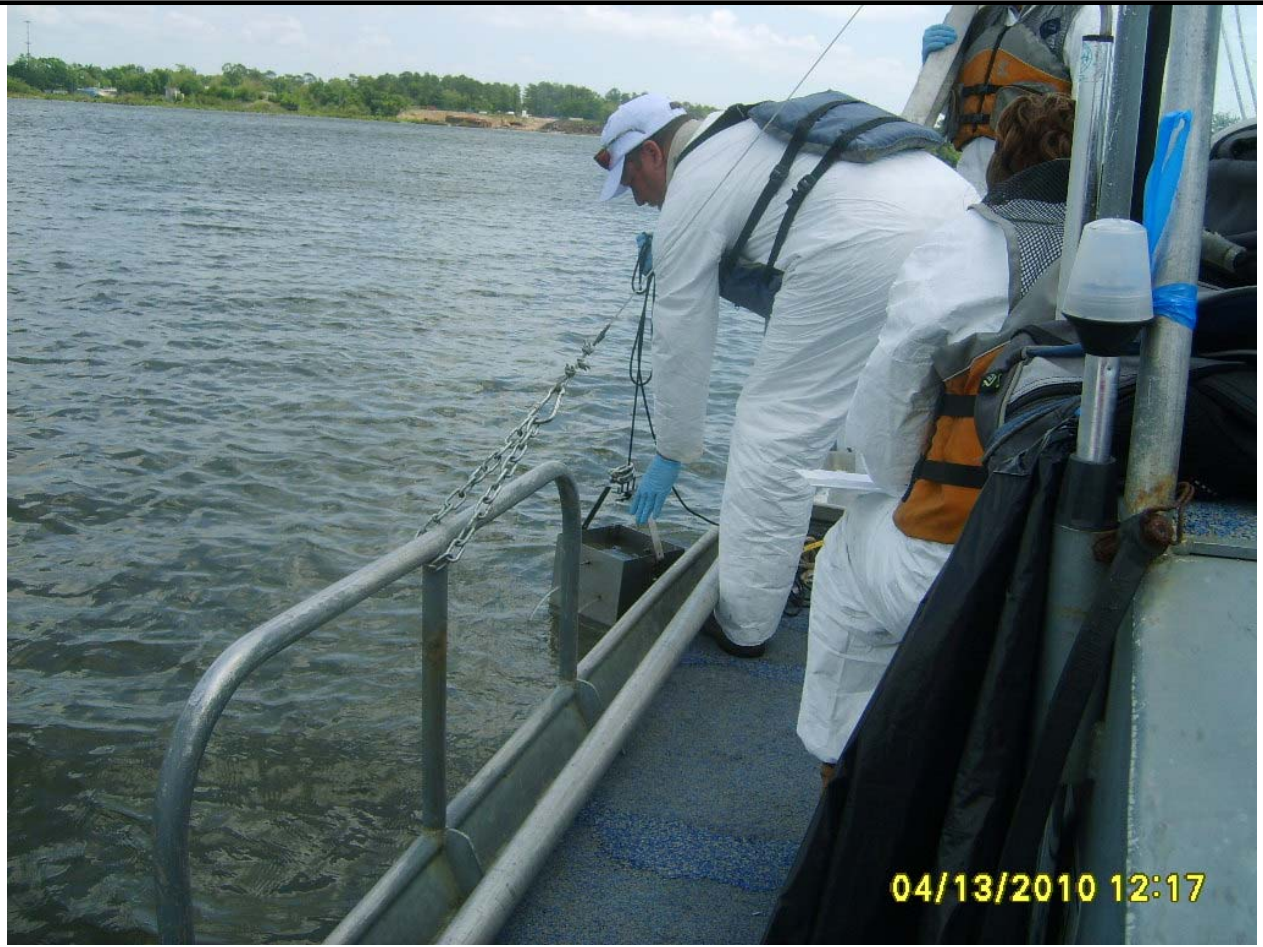
Logbook Photo #	102-0732
US EPA ID / Task Order Number	TXN000606611 / TO-0002-10-03-02
Site	San Jacinto River Waste Pits
Location Address	29.7944 N, 95.0625 W
City, State, ZIP code	Baytown, Texas
County	Harris
Direction/Orientation	North
Date	April 13, 2010
Time	1217 hrs
Photographer	Karen Berecz (START)
Witness	Jason Kase (PRP Contractor – Anchor QEA)
Description:	
Collecting sediment sample at SJA5.

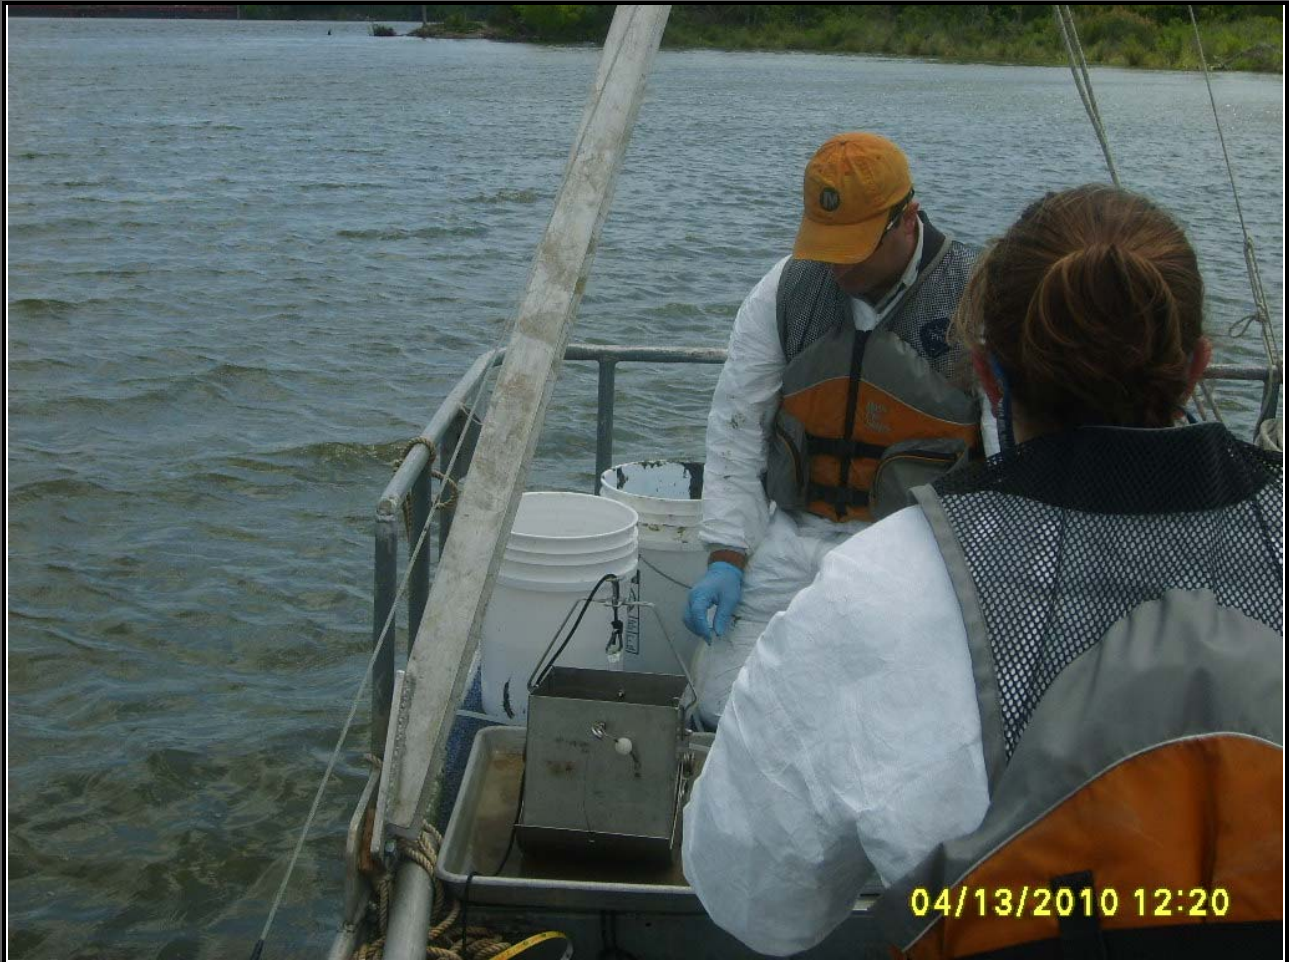
Logbook Photo #	102-0733
US EPA ID / Task Order Number	TXN000606611 / TO-0002-10-03-02
Site	San Jacinto River Waste Pits
Location Address	29.7944 N, 95.0625 W
City, State, ZIP code	Baytown, Texas
County	Harris
Direction/Orientation	North
Date	April 13, 2010
Time	1220 hrs
Photographer	Karen Berecz (START)
Witness	Jason Kase (PRP Contractor – Anchor QEA)
Description:	
Siphoning water off sample SJA5.

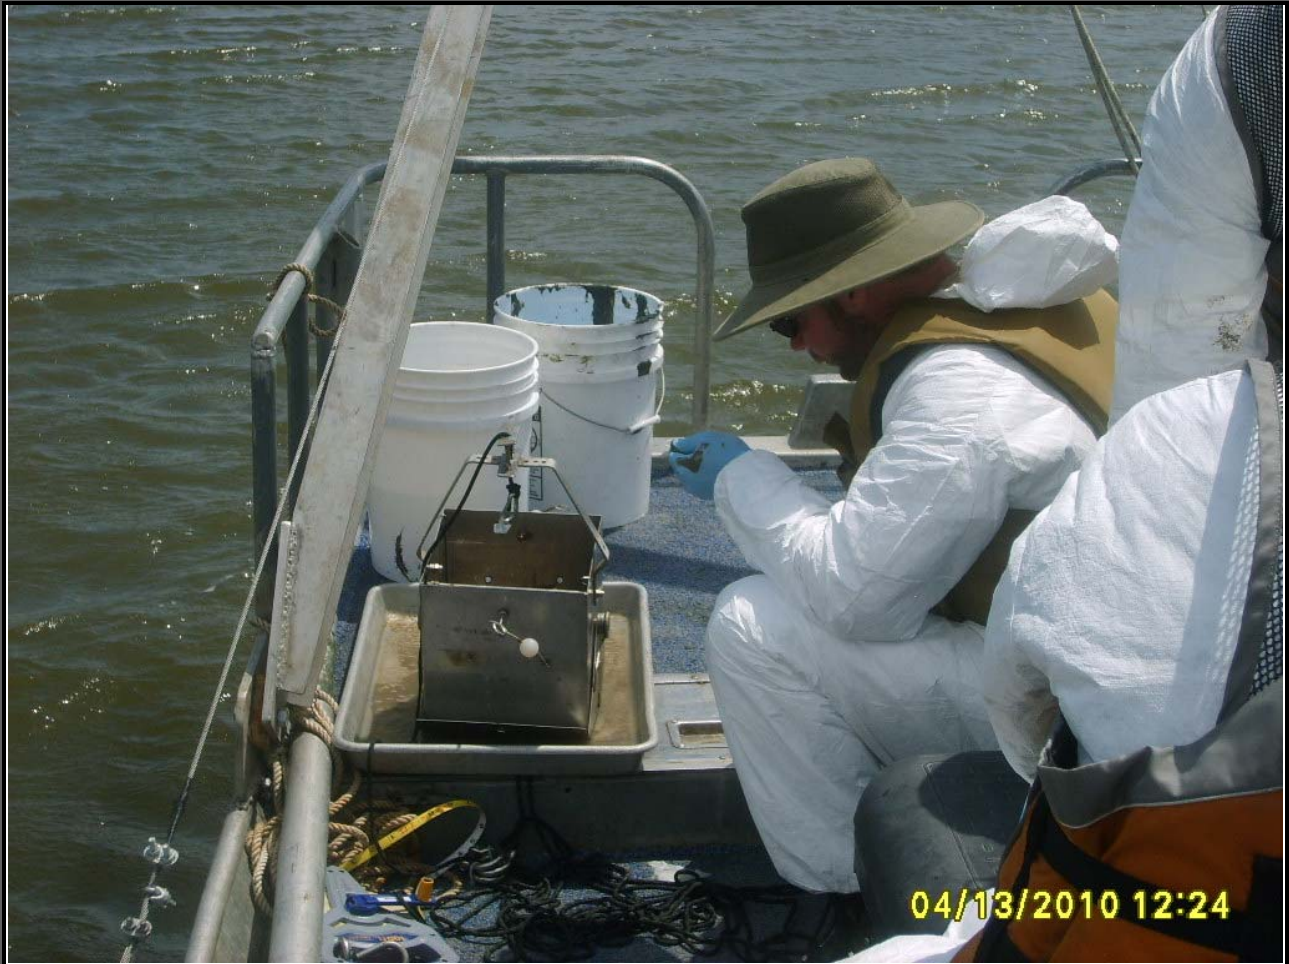
Logbook Photo #	102-0734
US EPA ID / Task Order Number	TXN000606611 / TO-0002-10-03-02
Site	San Jacinto River Waste Pits
Location Address	29.7944 N, 95.0625 W
City, State, ZIP code	Baytown, Texas
County	Harris
Direction/Orientation	North
Date	April 13, 2010
Time	1224 hrs
Photographer	Karen Berecz (START)
Witness	Jason Kase (PRP Contractor – Anchor QEA)
Description: Examining sample for SJA5.

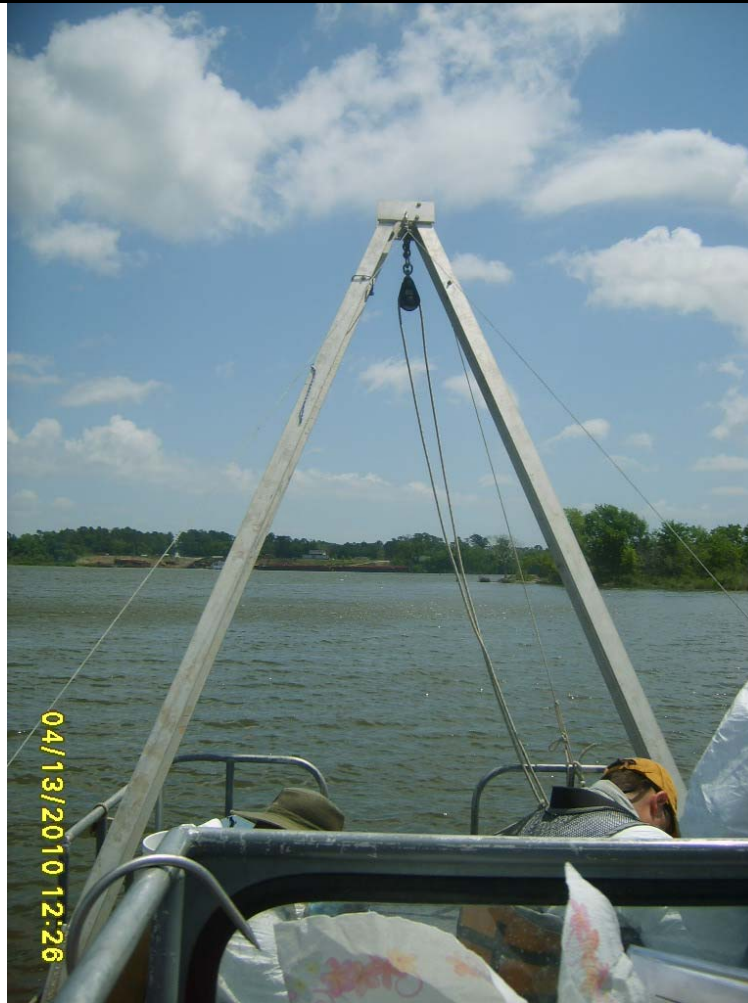
Logbook Photo #	102-0735
US EPA ID / Task Order Number	TXN000606611 / TO-0002-10-03-02
Site	San Jacinto River Waste Pits
Location Address	29.7944 N, 95.0625 W
City, State, ZIP code	Baytown, Texas
County	Harris
Direction/Orientation	South
Date	April 13, 2010
Time	1226 hrs
Photographer	Karen Berecz (START)
Witness	Jason Kase (PRP Contractor – Anchor QEA)
Description:	
Transect A toward waste pits from SJA5.

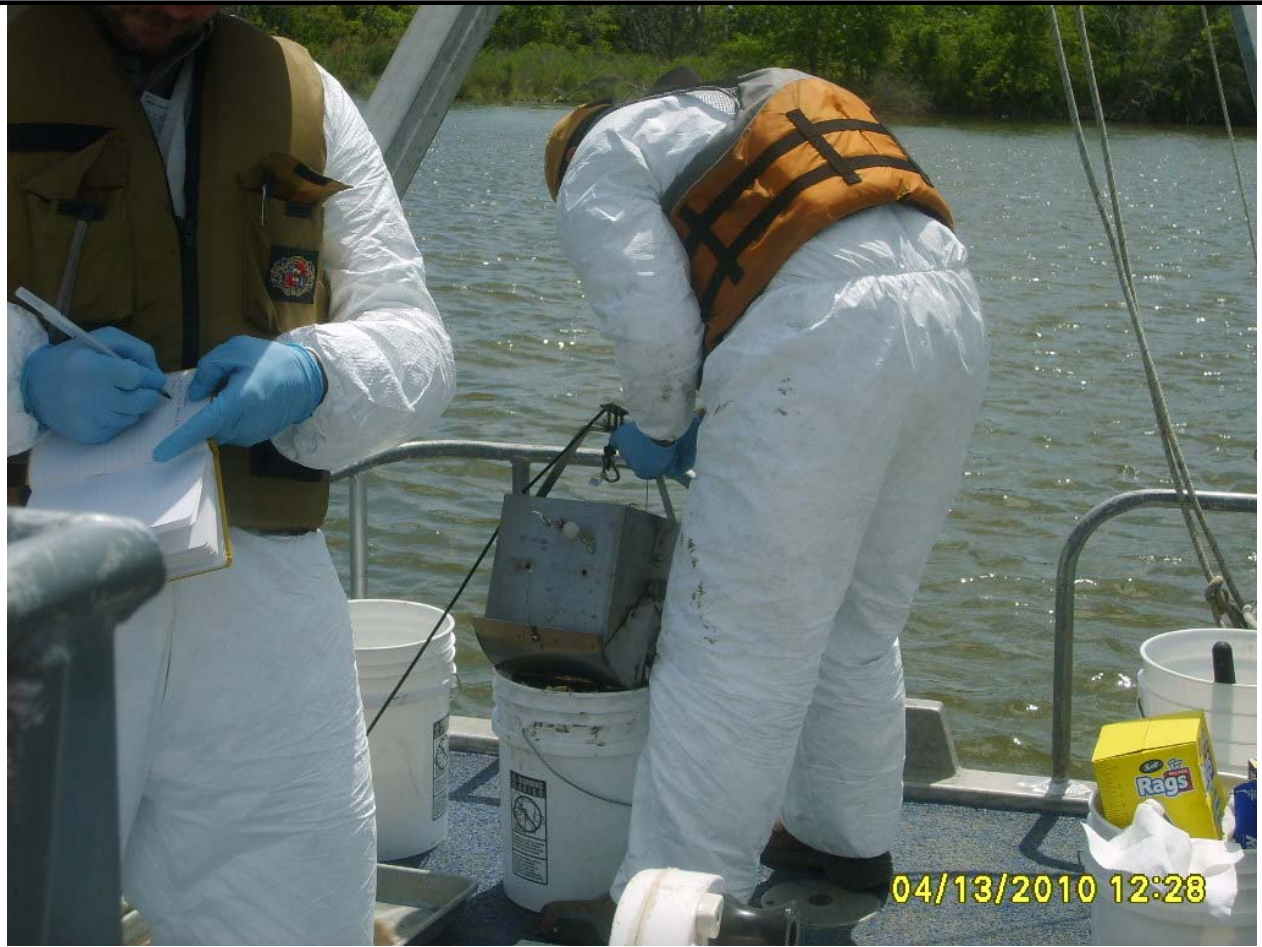
Logbook Photo #	102-0736
US EPA ID / Task Order Number	TXN000606611 / TO-0002-10-03-02
Site	San Jacinto River Waste Pits
Location Address	29.7944 N, 95.0625 W
City, State, ZIP code	Baytown, Texas
County	Harris
Direction/Orientation	North
Date	April 13, 2010
Time	1228 hrs
Photographer	Karen Berecz (START)
Witness	Jason Kase (PRP Contractor – Anchor QEA)
Description:	
Dumping waste into bucket from SJA5.

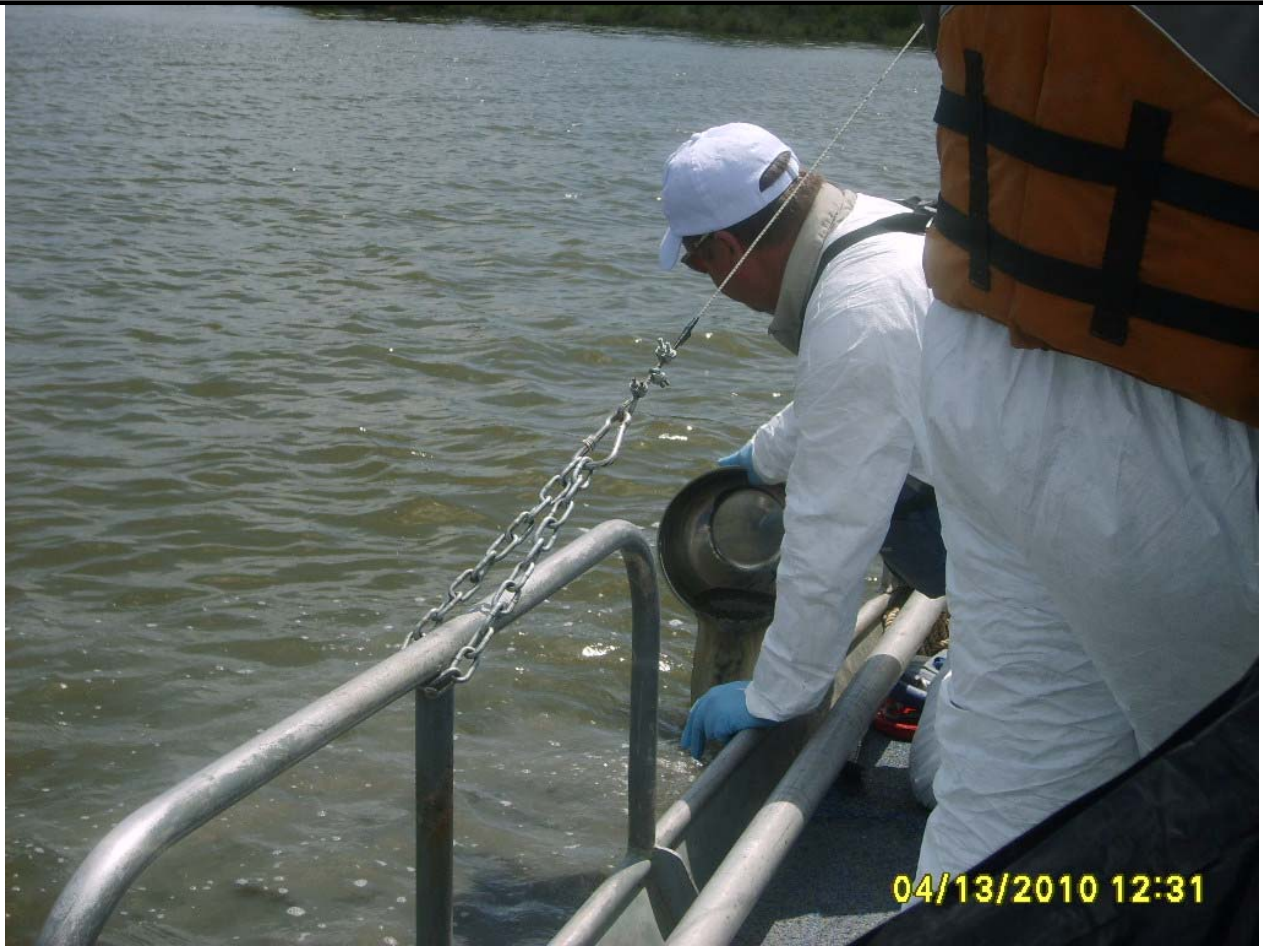
PHOTO 102-0737. LOOKING NORTH AT NEAR DECON'ING STAINLESS STEEL BOWL AFTER SAMPLING STAY.

Logbook Photo #	102-0737
US EPA ID / Task Order Number	TXN000606611 / TO-0002-10-03-02
Site	San Jacinto River Waste Pits
Location Address	29.7944 N, 95.0625 W
City, State, ZIP code	Baytown, Texas
County	Harris
Direction/Orientation	North
Date	April 13, 2010
Time	1231 hrs
Photographer	Karen Berecz (START)
Witness	Jason Kase (PRP Contractor – Anchor QEA)
Description: Deconing bowl after sampling at SJA5.

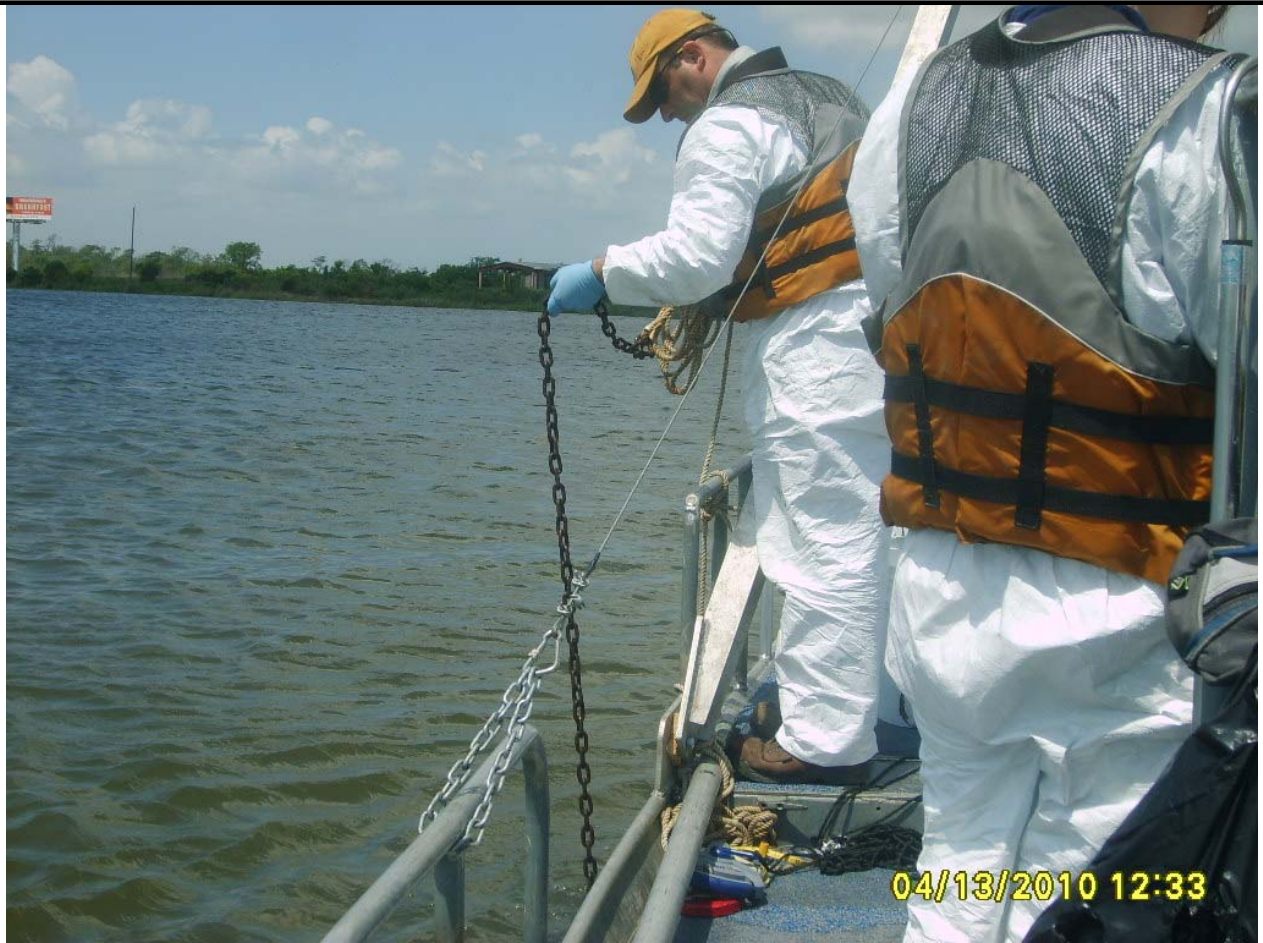
Logbook Photo #	102-0738
US EPA ID / Task Order Number	TXN000606611 / TO-0002-10-03-02
Site	San Jacinto River Waste Pits
Location Address	29.7944 N, 95.0625 W
City, State, ZIP code	Baytown, Texas
County	Harris
Direction/Orientation	Northwest
Date	April 13, 2010
Time	1233 hrs
Photographer	Karen Berecz (START)
Witness	Jason Kase (PRP Contractor – Anchor QEA)
Description:	
Pulling anchor at SJA5.

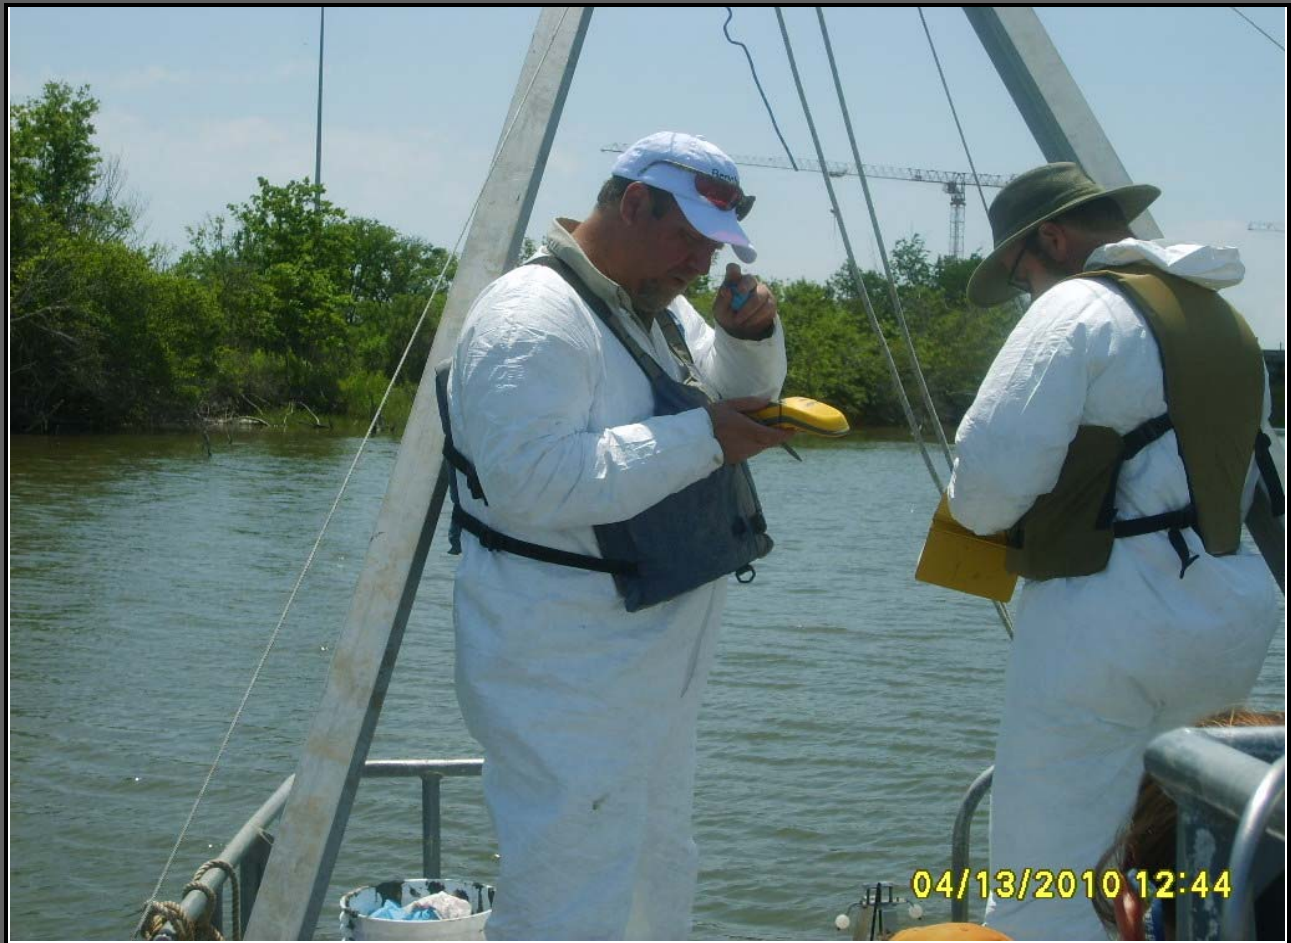
Logbook Photo #	102-0739
US EPA ID / Task Order Number	TXN000606611 / TO-0002-10-03-02
Site	San Jacinto River Waste Pits
Location Address	29.7944 N, 95.0625 W
City, State, ZIP code	Baytown, Texas
County	Harris
Direction/Orientation	Southwest
Date	April 13, 2010
Time	1244 hrs
Photographer	Karen Berecz (START)
Witness	Jason Kase (PRP Contractor – Anchor QEA)
Description: Obtaining GPS coordinates for SJA3.

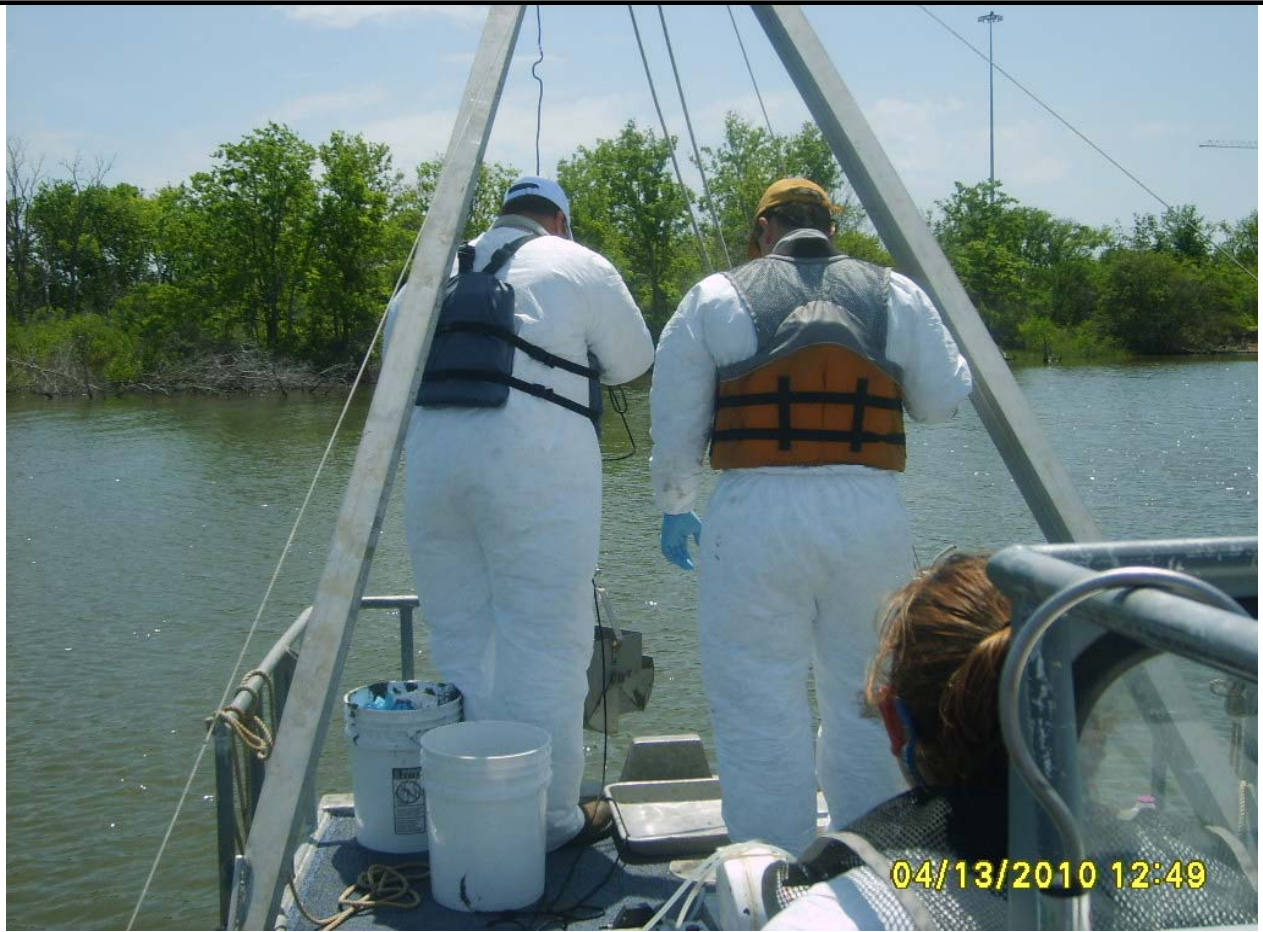
Logbook Photo #	102-0740
US EPA ID / Task Order Number	TXN000606611 / TO-0002-10-03-02
Site	San Jacinto River Waste Pits
Location Address	29.7944 N, 95.0625 W
City, State, ZIP code	Baytown, Texas
County	Harris
Direction/Orientation	Northeast
Date	April 13, 2010
Time	1249 hrs
Photographer	Karen Berecz (START)
Witness	Jason Kase (PRP Contractor – Anchor QEA)
Description: Dropping Eckman Dredge at SJA3.

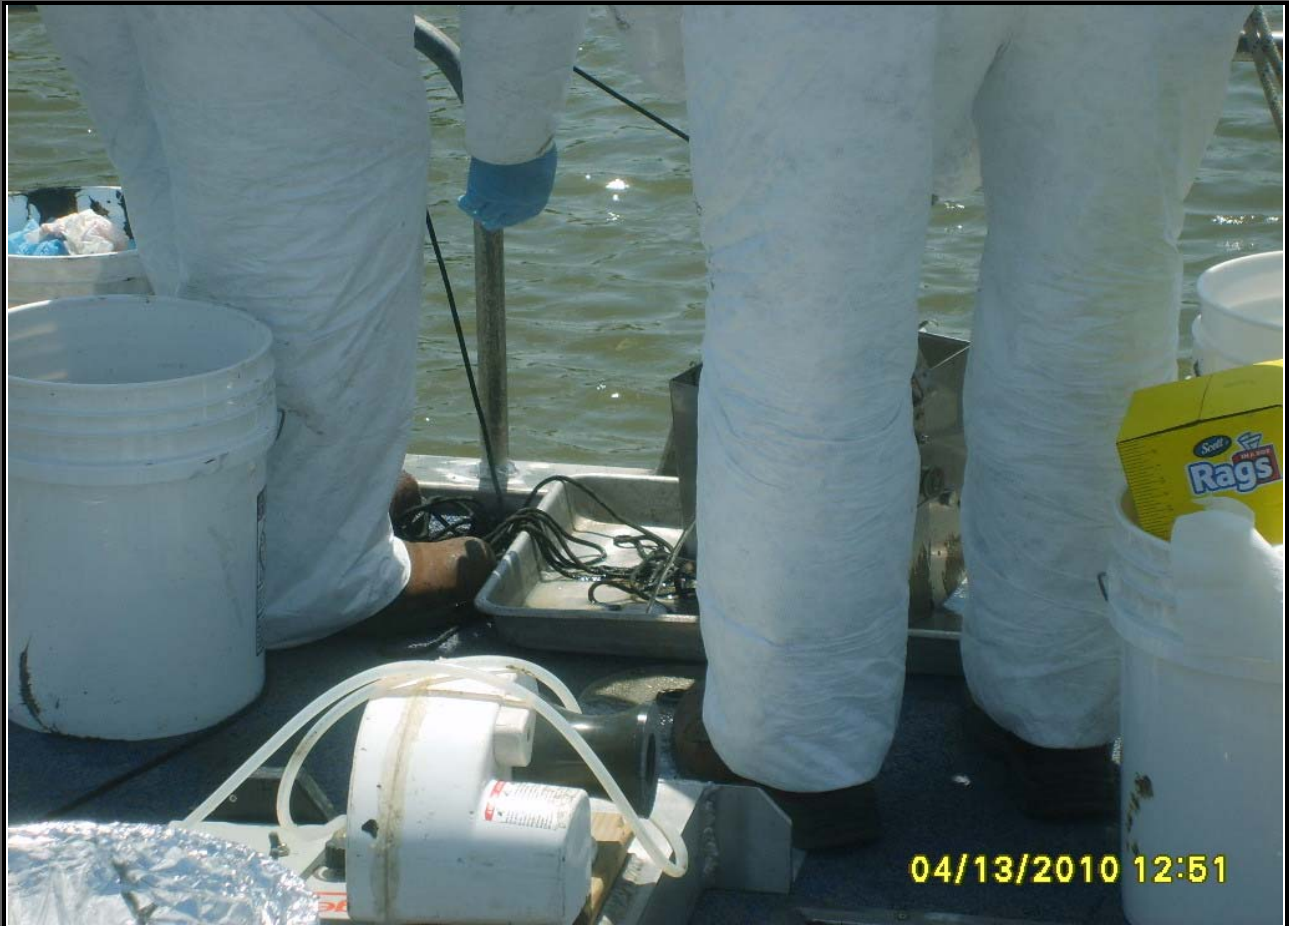
Logbook Photo #	102-0741
US EPA ID / Task Order Number	TXN000606611 / TO-0002-10-03-02
Site	San Jacinto River Waste Pits
Location Address	29.7944 N, 95.0625 W
City, State, ZIP code	Baytown, Texas
County	Harris
Direction/Orientation	Northeast
Date	April 13, 2010
Time	1521 hrs
Photographer	Karen Berecz (START)
Witness	Jason Kase (PRP Contractor – Anchor QEA)
Description:	
Pulling up the Eckman Dredge at SJA3.
